SAFETY ANALYSIS (SA)
OF THE
HAZARDOUS WASTE DISPOSAL FACILITIES
(BUILDINGS 514, 612, and 614)
AT THE LAWRENCE LIVERMORE LABORATORY

December 13, 1979

Lawrence
Livermore
Laboratory

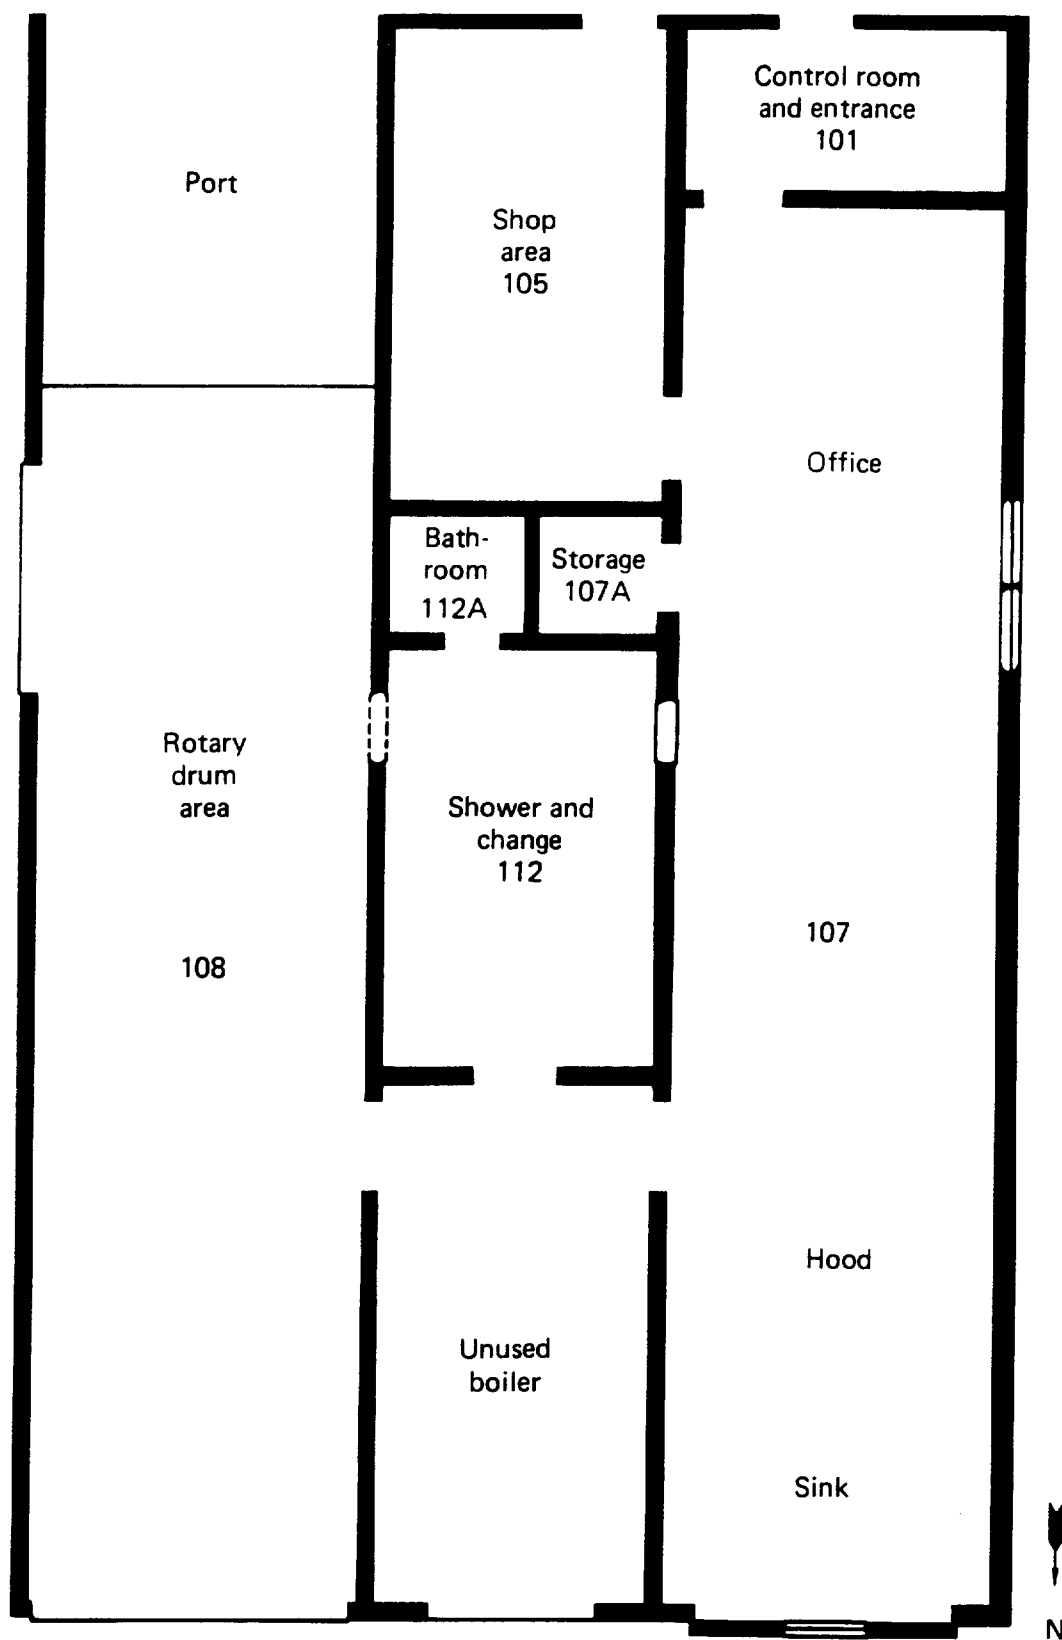
Fig. 2-2 Plan View of Bldg 514

Building 514 is a concrete structure. The 200-m² floor area is shown in its present configuration in Fig. 2-2. The surface of the floors in Rooms 108

and 112 have been painted with a polyamide cured epoxy in order to make decontamination easier.

- There is a potential head knocker problem to the operator of the diatomaceous-earth, rotary drum filter in Bldg 514. Recommendation: Relocate or pad piping, or provide hard-hat protection.

- Diatomaceous earth dust is produced in air when emptying bags of this material in the rotary drum area in Bldg 514. Recommendation: Require the use of suitable respiratory protection.
